# TEST REPORT

**Reference No.** ..... : WTF19U03015794V  
**Applicant** ..... : Mid Ocean Brands B.V.  
**Address** ..... : 7/F., Kings Tower, 111 King Lam Street, Cheung Sha Wan, Kowloon, Hong Kong  
**Manufacturer** ..... : 108699  
**Address** ..... : -  
**Product Name** ..... : Car charger with belt cutter  
**Model No.** ..... : MO9314  
**Standards** ..... : EN 50498:2010  
**Test Category** ..... : CE-EMC  
**Test Item** ..... : All item  
**Date of Receipt sample** ..... : 2019-03-20  
**Date of Test** ..... : 2019-03-27 to 2019-05-20  
**Date of Issue** ..... : 2019-05-21  
**Test Report Form No.** ..... : WT-50498A-01B  
**Test Result** ..... : Pass

**Product Name** ..... : Car charger with belt cutter

**Model No.** ..... : MO9314

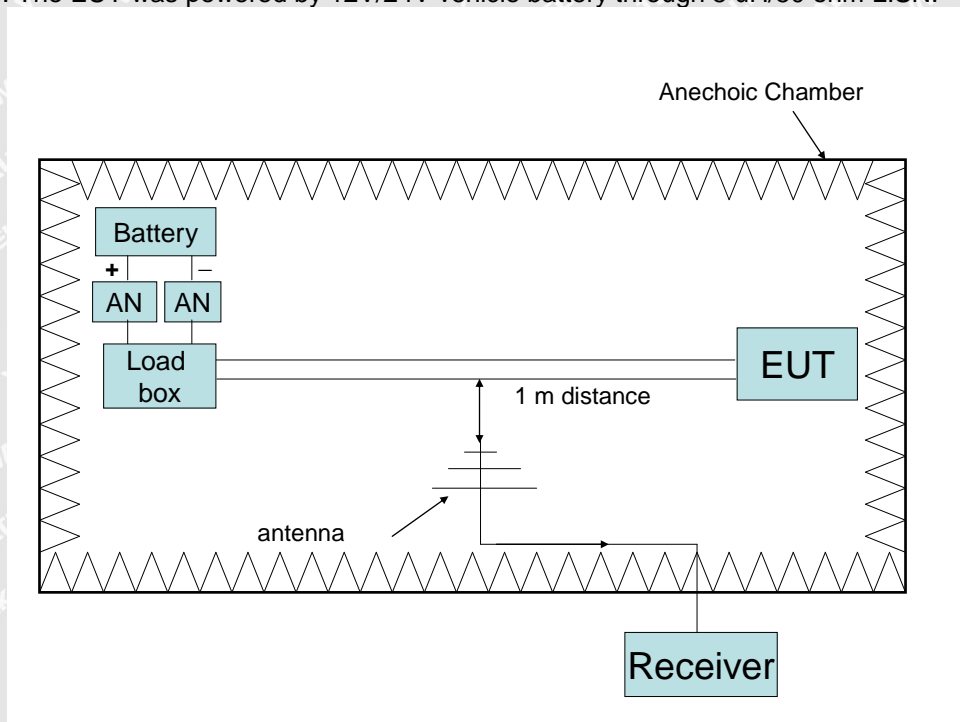
### 5.1.2 Block Diagram of Test Setup and procedure

The EUT was insulated placed 50mm above the ground plane, the ground plane was in a height of 1m to the reference plane of semi-anechoic chamber and with electrical connection. No additional electric connection was made between the EUT and ground plane as the EUT will not be intended to be bonded to the bodywork of the vehicle. The EUT was powered by 12V/24V vehicle battery through 5 uH/50 ohm LISN.

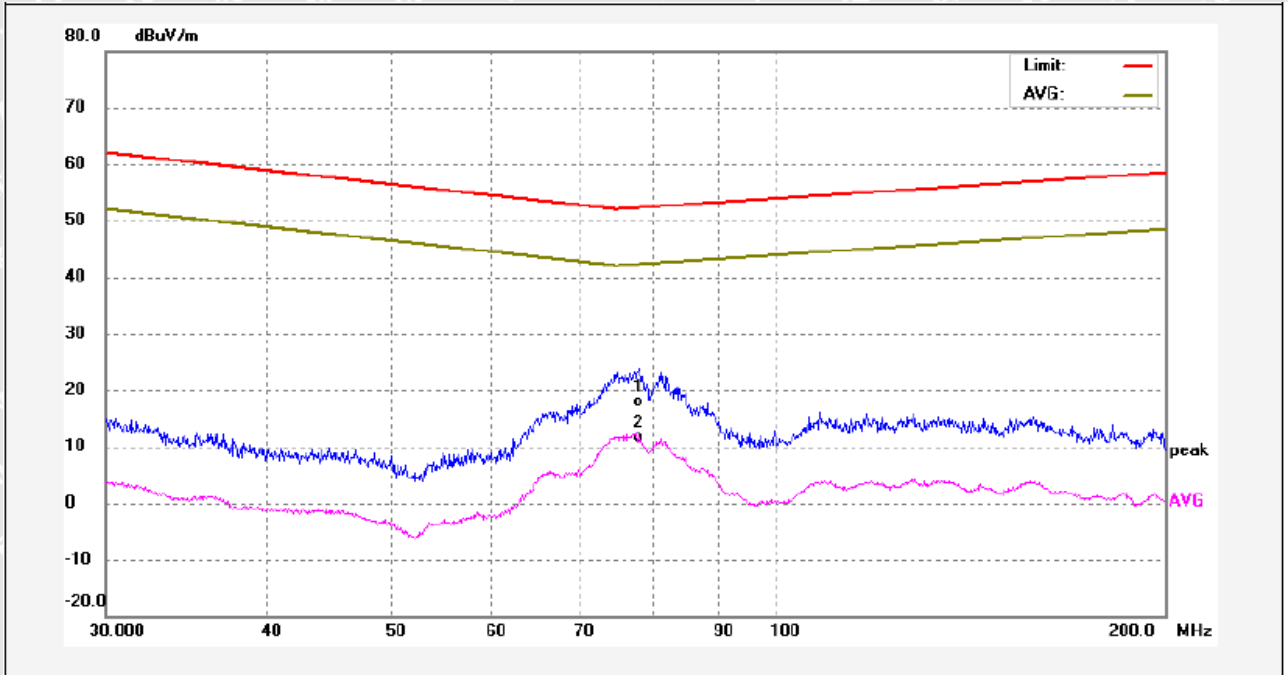
1. Test Voltage: DC 13.5V    Operation Mode: Full Load  
 30MHz-200MHz    Antenna-Horizontal:

No.	Freq. (MHz)	Reading (dBuV/m)	Factor (dB)	Result (dBuV/m)	Limit dBuV/	Margin (dB)	Detector	Remark
1	78.1500	9.47	8.52	17.99	52.27	-34.28	QP	
2	78.1500	3.20	8.52	11.72	42.27	-30.55	AVG

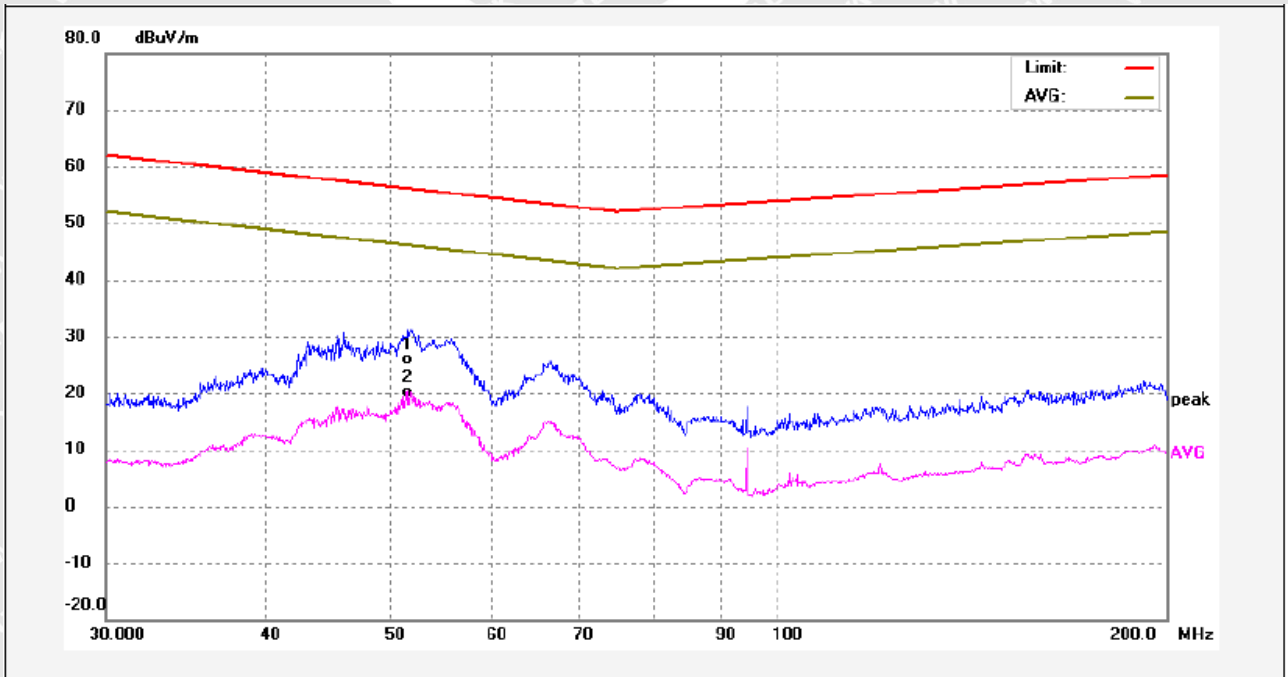
30MHz-200MHz    Antenna Vertical:

No.	Freq. (MHz)	Reading (dBuV/m)	Factor (dB)	Result (dBuV/m)	Limit dBuV/	Margin (dB)	Detector	Remark
1	51.5500	13.22	12.59	25.81	56.09	-30.28	QP	
2	51.5500	7.54	12.59	20.13	46.09	-25.96	AVG

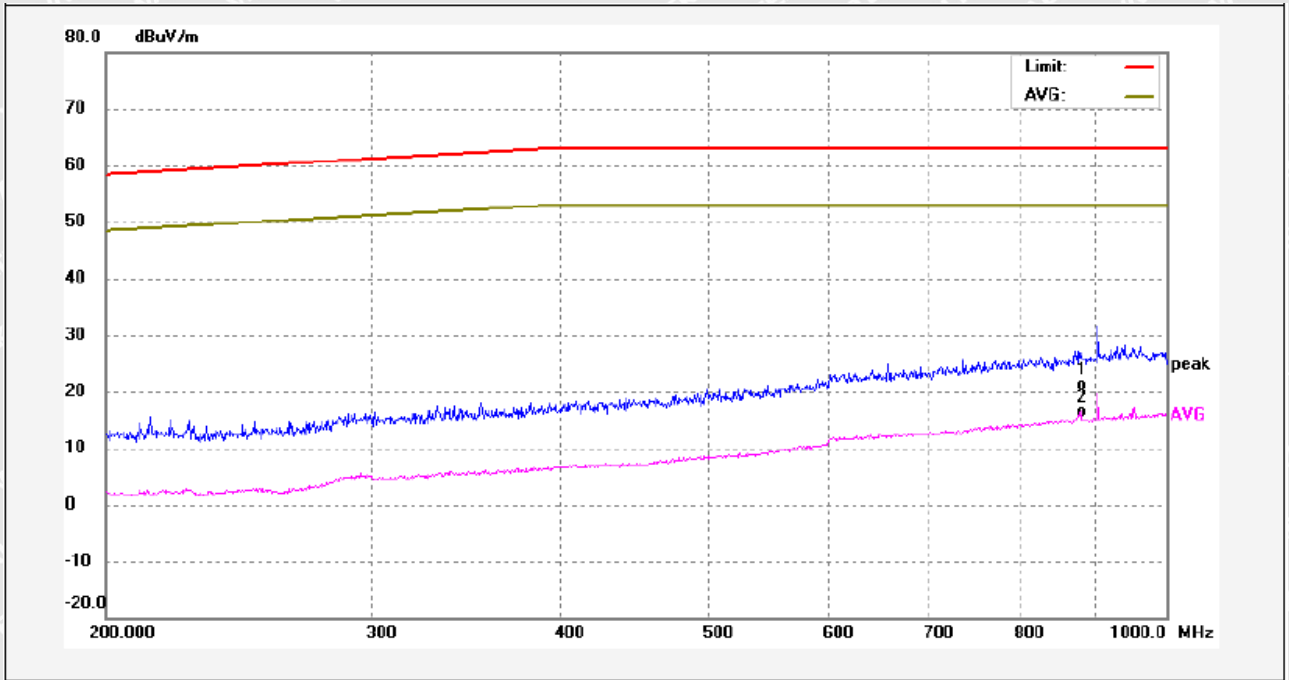
200MHz-1000MHz Antenna-Horizontal:

No.	Freq. (MHz)	Reading (dBuV/m)	Factor (dB)	Result (dBuV/m)	Limit dBuV/	Margin (dB)	Detector	Remark
1	877.8500	-2.65	23.90	21.25	63.00	-41.75	QP	
2	877.8500	-7.50	23.90	16.40	53.00	-36.60	AVG

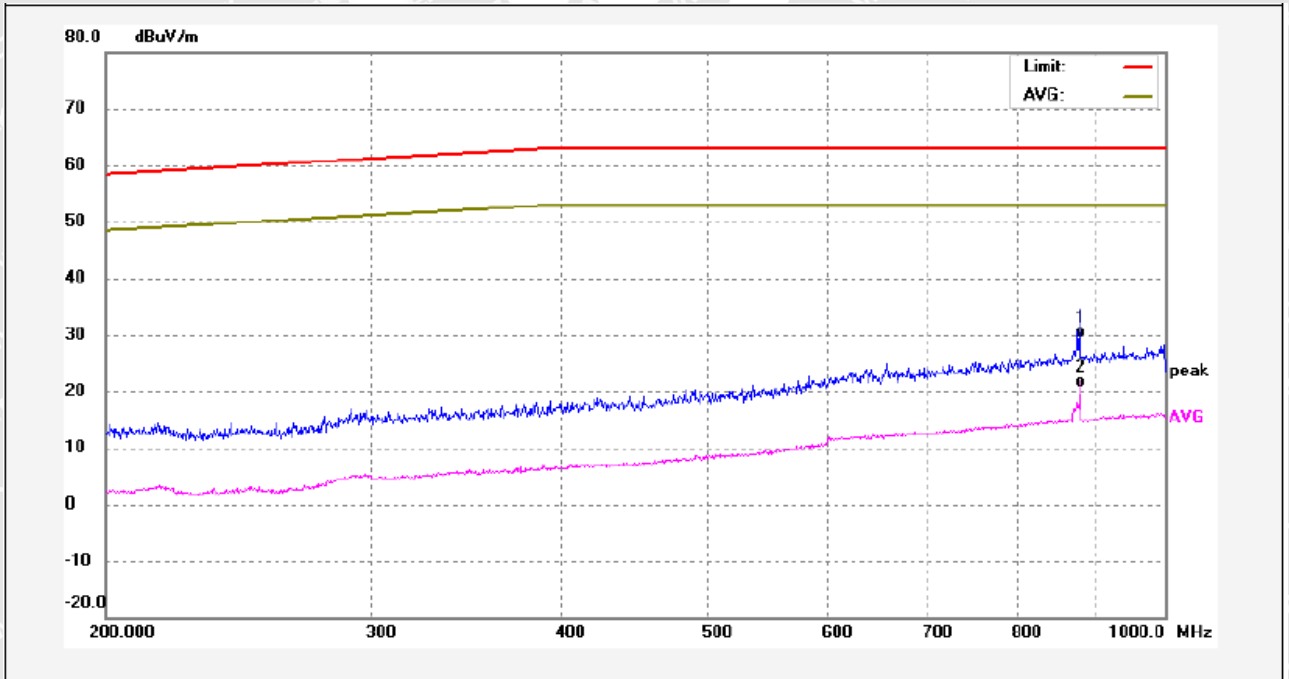
200MHz-1000MHz Antenna-Vertical:

No.	Freq. (MHz)	Reading (dBuV/m)	Factor (dB)	Result (dBuV/m)	Limit dBuV/	Margin (dB)	Detector	Remark
1	879.9000	6.39	23.91	30.30	63.00	-32.70	QP	
2	879.9000	-2.34	23.91	21.57	53.00	-31.43	AVG

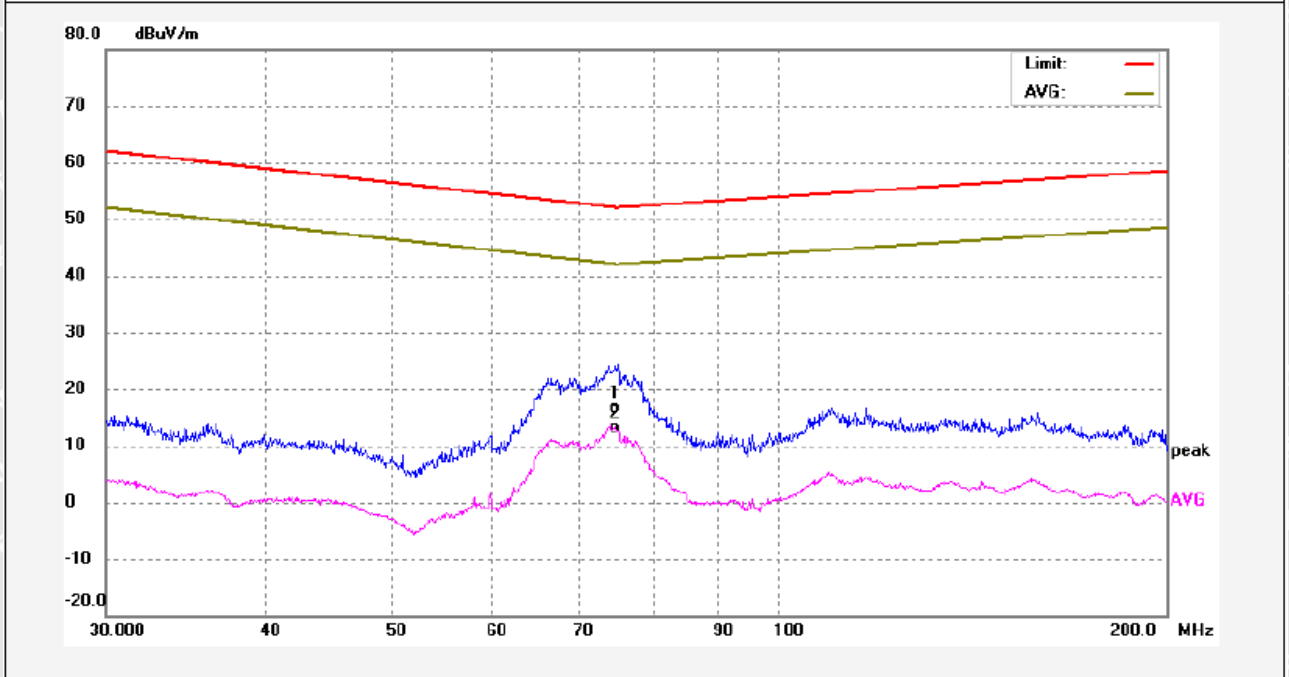
30MHz-200MHz Antenna-Horizontal:

No.	Freq. (MHz)	Reading (dBuV/m)	Factor (dB)	Result (dBuV/m)	Limit dBuV/	Margin (dB)	Detector	Remark
1	75.1000	8.51	8.02	16.53	52.01	-35.48	QP	
2	75.1000	5.04	8.02	13.06	42.01	-28.95	AVG

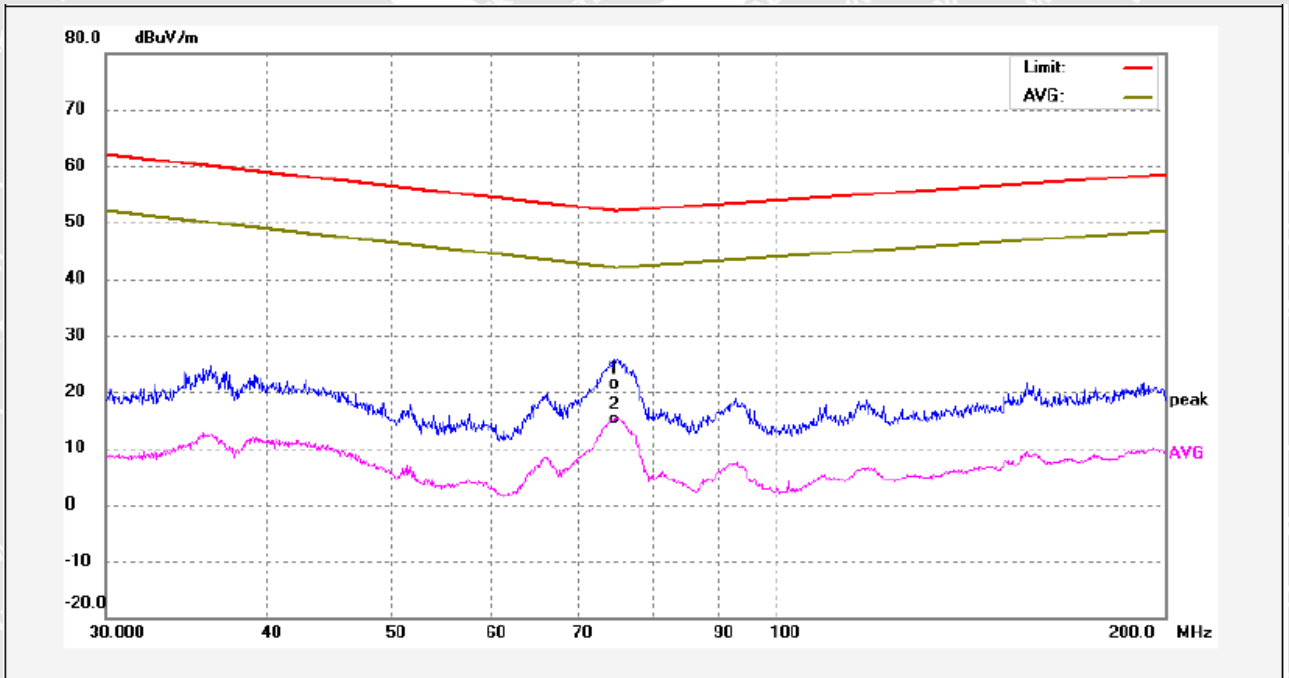
30MHz-200MHz Antenna-Vertical:

No.	Freq. (MHz)	Reading (dBuV/m)	Factor (dB)	Result (dBuV/m)	Limit dBuV/	Margin (dB)	Detector	Remark
1	75.1000	13.47	8.02	21.49	52.01	-30.52	QP	
2	75.1000	7.19	8.02	15.21	42.01	-26.80	AVG

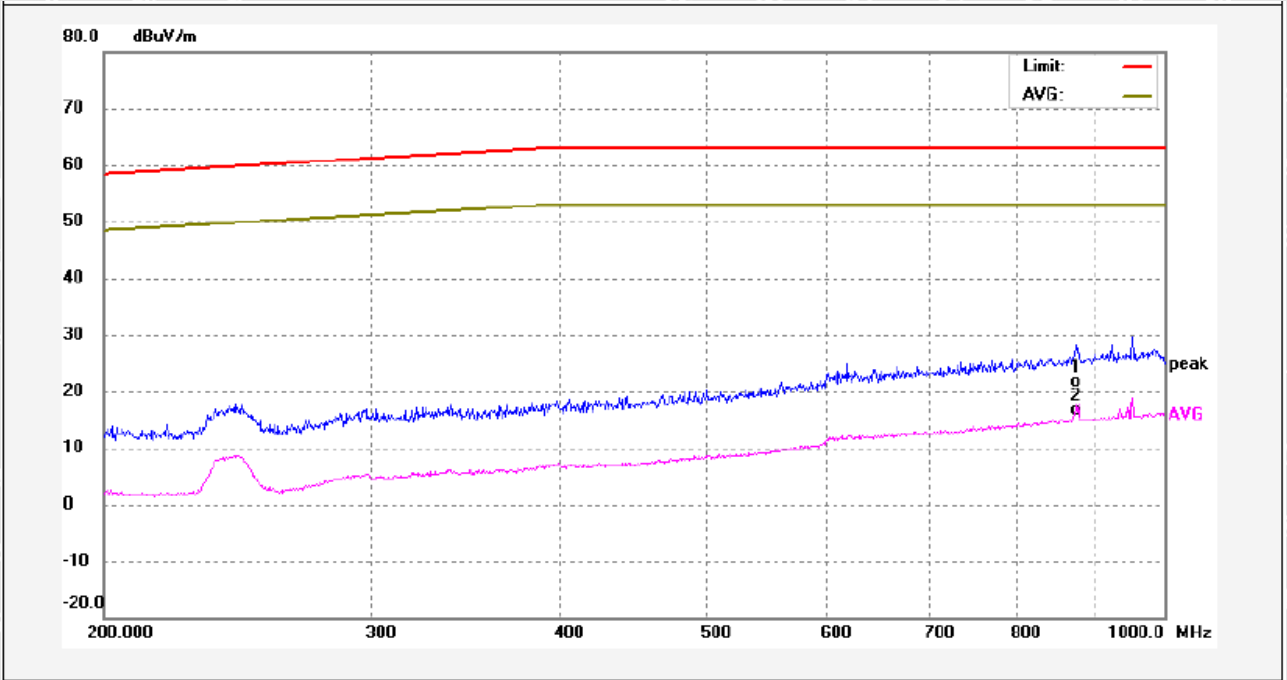
200MHz-1000MHz Antenna-Horizontal:

No.	Freq. (MHz)	Reading (dBuV/m)	Factor (dB)	Result (dBuV/m)	Limit dBuV/	Margin (dB)	Detector	Remark
1	874.4000	-2.34	23.87	21.53	63.00	-41.47	QP	
2	874.4000	-7.26	23.87	16.61	53.00	-36.39	AVG

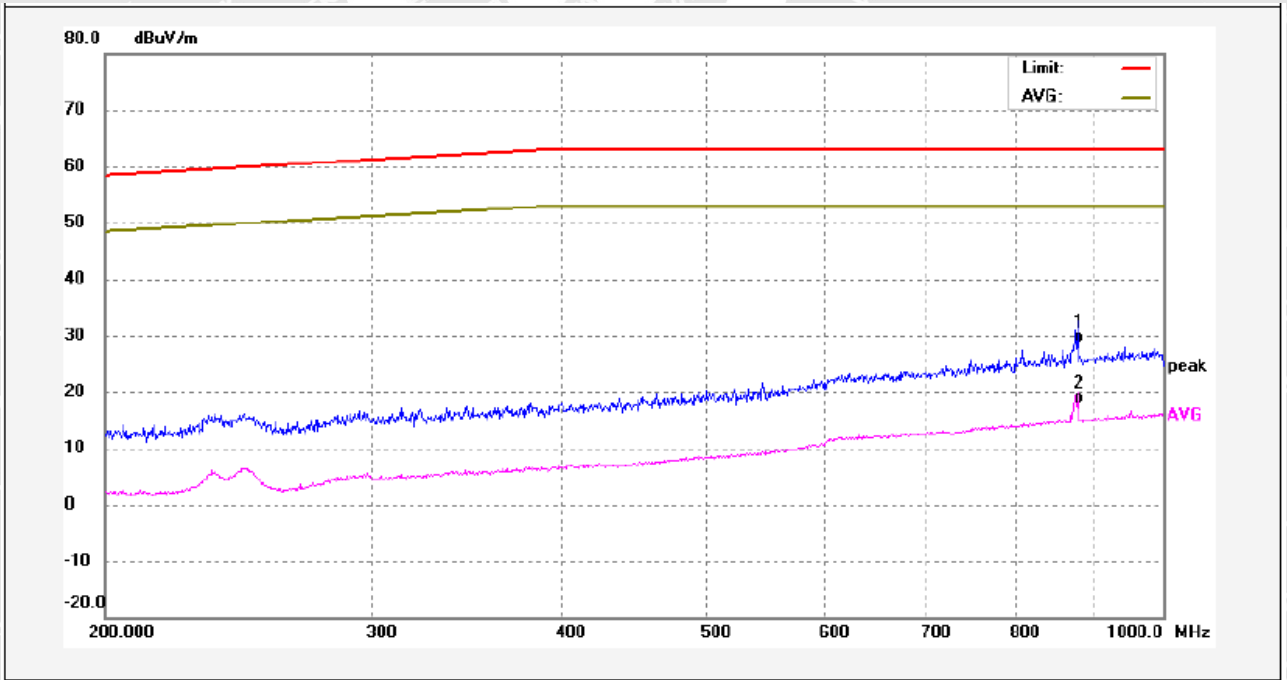
200MHz-1000MHz Antenna-Vertical:

No.	Freq. (MHz)	Reading (dBuV/m)	Factor (dB)	Result (dBuV/m)	Limit dBuV/	Margin (dB)	Detector	Remark
1	879.9500	5.65	23.91	29.56	63.00	-33.44	QP	
2	879.9500	-4.97	23.91	18.94	53.00	-34.06	AVG

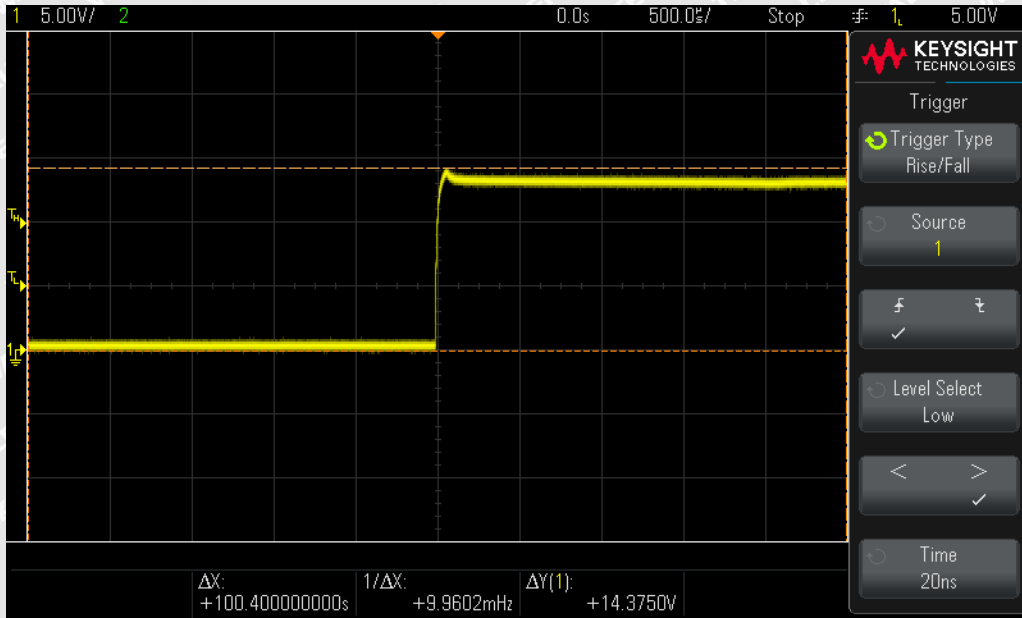
Fast on:

Pulse		Maximum allowed pulse amplitude	Measurement Level	Result
Fast	Switch on		Positive: +75V	+14.375V
	Switch off	-13.875V		Pass
Slow	Switch on	Negative: -100V	+14.5V	Pass
	Switch off		-13.25V	Pass

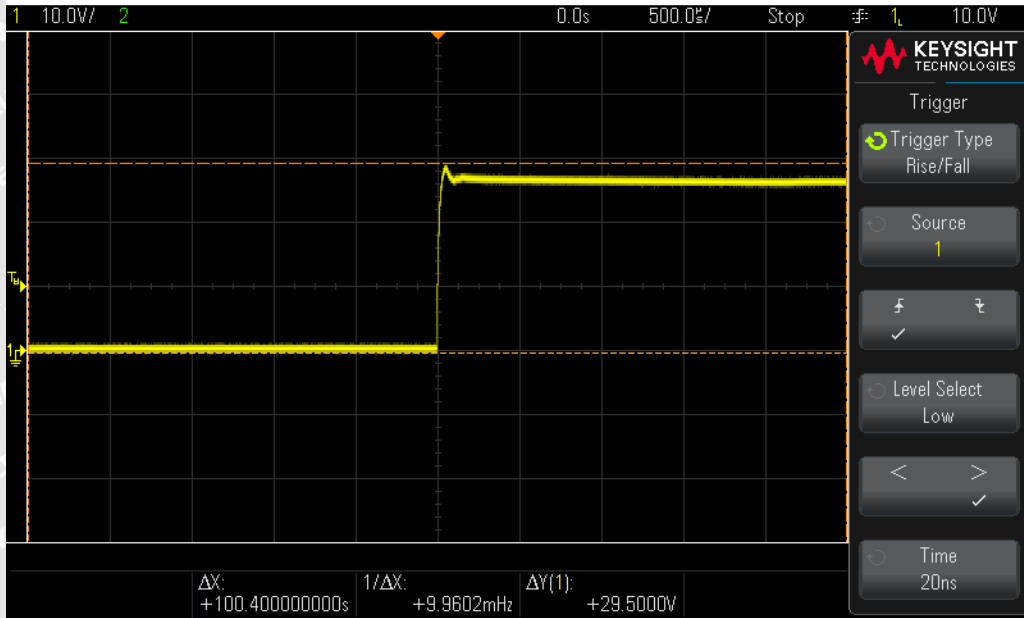
Fast on:

Pulse		Maximum allowed pulse amplitude	Measurement Level	Result
Fast	Switch on	Positive: +150V	+29.5V	Pass
	Switch off		-27.125V	Pass
Slow	Switch on	Negative: -450V	+29.375V	Pass
	Switch off		-26.625V	Pass

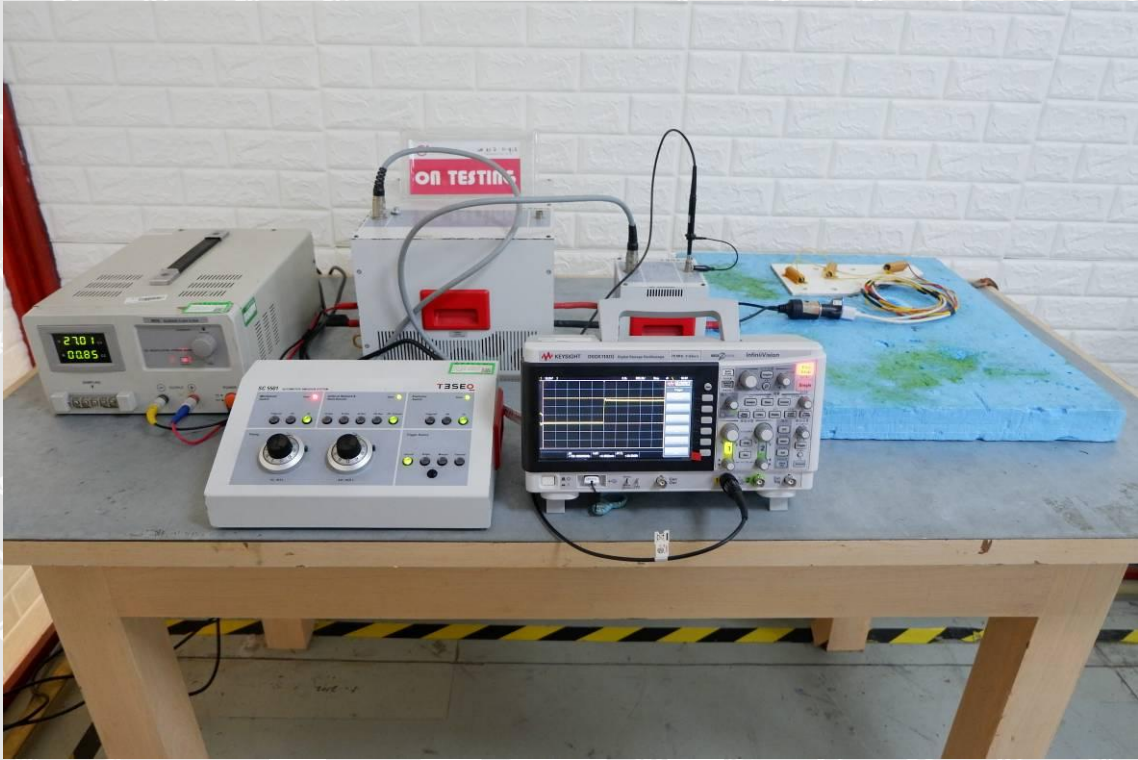
Fast

## 6.2 Photograph –Conducted Transient Disturbances Test Setup
