## Test report

23A-012306

Description:	Crystal award in octagon shape	Labeled age grade:	-
Supplier:	118518	Tested age grade:	-
Country of origin:	-	Materials:	Glass
Country of distribution:	Europe	Buyer:	Mid Ocean Brands B.V.
Model #:	MO2135		
Quantity submitted:	1 PC

### Regulation (EC) No. 1907/2006 REACH Annex XVII, Item 63 Lead in Substrate Materials

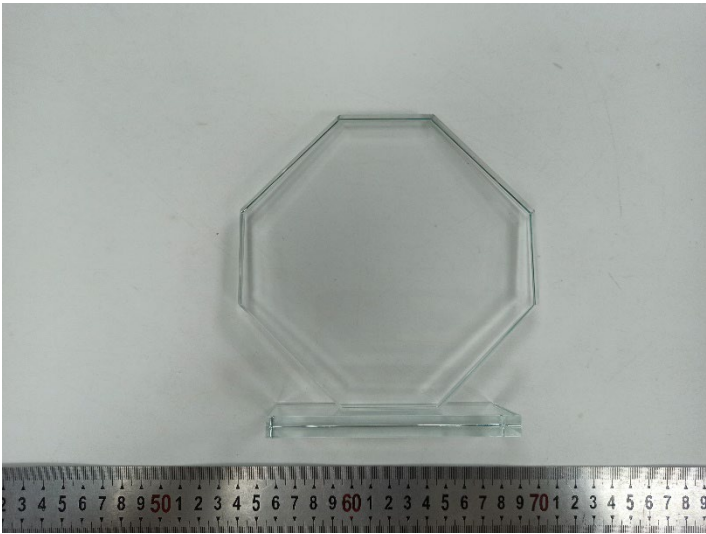
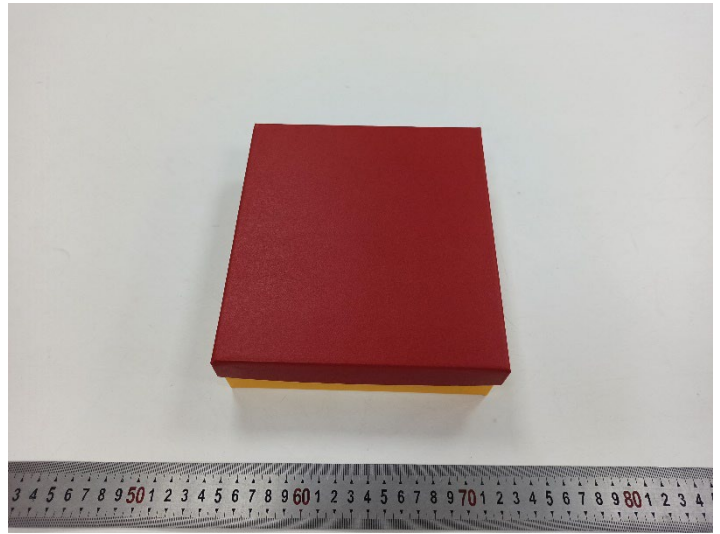
### Sample photo:

Specimen #	Specimen description	Location
1	Transparent glass	Main body
